# TROUBLE TRACER CHART VALVE TRAIN

# TROUBLE TRACER CHART CAMTRAIN

# VW 1.9 TDi PD – Fitting Instructions

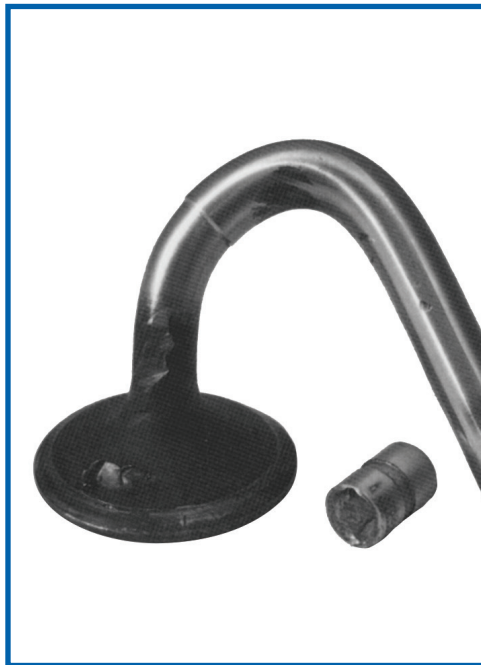
## Stem breakage through collet groove

**Symptom:** Excessive mechanical noise, bent stem and possible head detachment.  
**Cause:** Poor assembly allowing uneven loading. Poor handling, dropping etc. Bouncing the valve after fitting by hitting the tip with a hammer. Valve bounce from excessive seating velocity.  
**Remedy:** May not be possible due to extreme damage this failure can cause, however: Check seats, guides, springs, pistons and bores for damage and repair where necessary. Do not overspeed the engine.

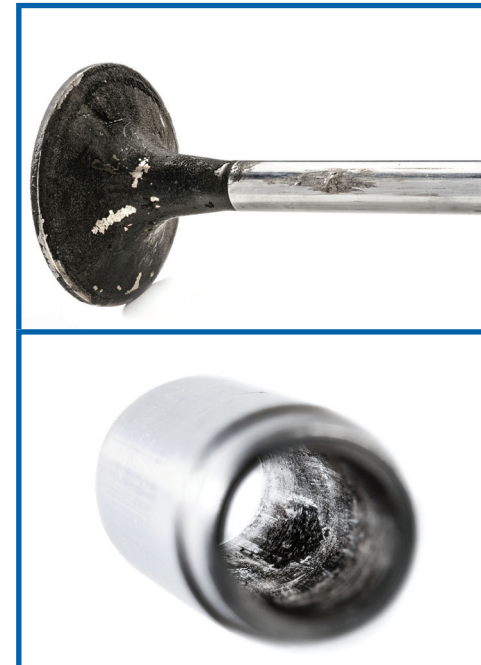
## Scuffed/sticking valve stem

**Symptom:** Poor performance due to low compression. Mechanical breakage due to sticking valves.  
**Cause:** Marginal lubrication from inadequate valve to stem clearance, causing scuffing or metal transfer. This may ream out the valve guide leading to the second cause, excessive oil from too great a clearance carbonising on the stem to cause sticking.  
**Remedy:** Ensure the valve stem to guide clearance is to specification. Ensure the correct valve stem seals have been used. Replace worn components where necessary.

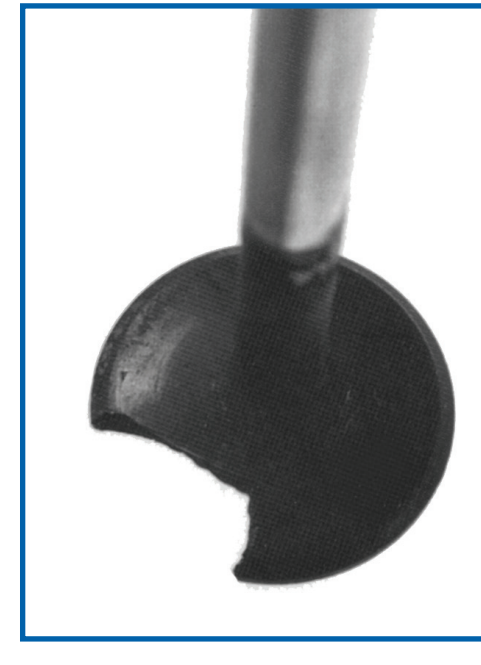
## Radial cracking of valve head, leading to a triangular segment breaking off

**Symptom:** Sudden mechanical noise. Rough running. Possible seizure.  
**Cause:** Poor temperature distribution across the valve head resulting in high tensile stresses in the rim, often combined with severe deflection due to abnormal combustion pressures and temperatures. Extreme thermal cycles, (continual sudden changing from full power to shut-down). Damage marks on the rim producing stress raisers. Mechanical overload from valve bounce.  
**Remedy:** Check the remaining valves for signs of cracking, replace where necessary. Ensure the correct valves have been used. Check engine settings, valve springs, guides and followers. Do not overspeed the engine.

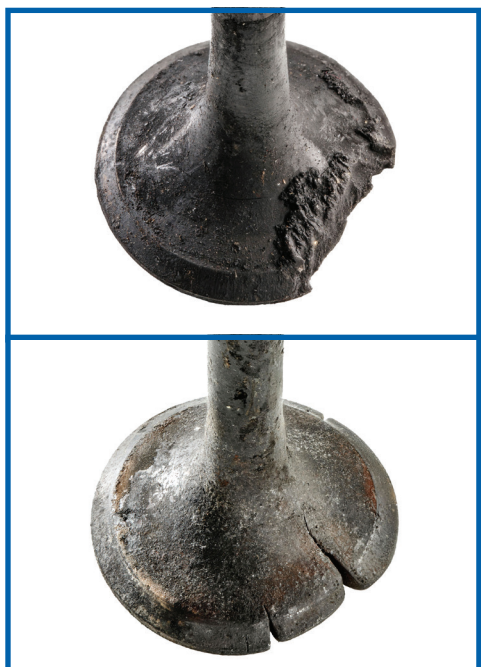
## "Gutter" burnt through valve rim

**Symptom:** Loss of power. Rough running.  
**Cause:** Valve clearance too small holding the valve off its seat. Sticking stem, poor/uneven seating or misalignment of the valve assembly. Overheating from pre-ignition. Excessive build up of carbon which flakes off the valve face to form a gas leakage path. Hard carbon particlespeen into the seat surface until enough indentations line up to form a gas leakage path.  
**Remedy:** Ensure valve clearance is to specification. Check stem to guide clearance and for any misalignment of the valve assembly. Check engine timing, carburettor settings and injection timing.

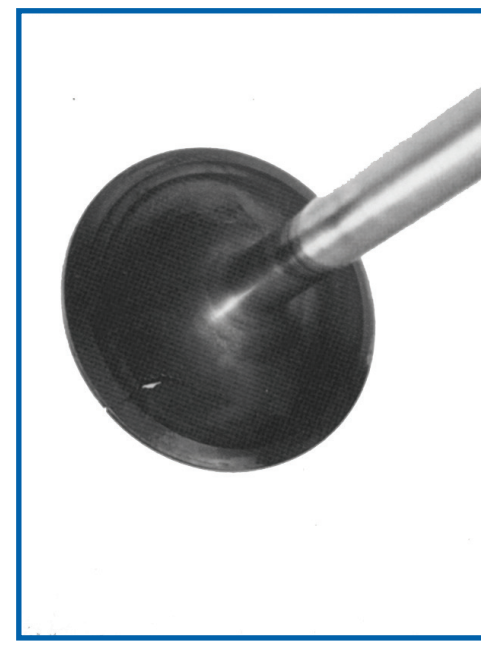
## Blow hole through valve head, starting from a radial crack

**Symptom:** Rough running. Loss of compression. Poor starting.  
**Cause:** Similar to a segmental breakage, but gas escapes through the crack and burns a hole. Extreme thermal cycles (continual sudden changing from full power to shut down). Damage marks on the rim producing stress raisers. Mechanical overload from valve bounce.  
**Remedy:** Check remaining valves for signs of cracking, replace where necessary. Ensure the correct valves have been used. Check engine settings, valve springs, guides and followers. Do not overspeed engine.

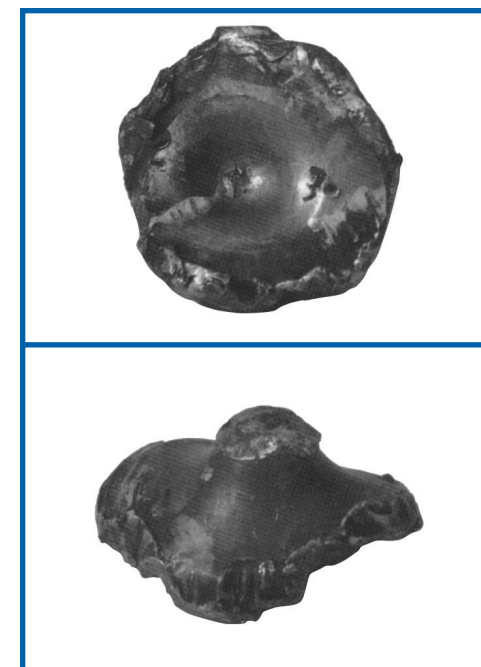
## Valve head breaking off stem

**Symptom:** Rough engine with sudden mechanical noise.  
**Cause:** Mechanical overload, such as seating velocity too high from excessive valve clearances. Valve bounce, valve to piston contact caused by overspeeding, weak or broken valve springs or sticking valve stem. Uneven seating due to misalignment or distorted valve.  
**Remedy:** May not be possible due to extreme damage this failure can cause, however: Check valve springs, guides and alignment and repair where necessary. Check seat guides, pistons and bores for damage. Reset the valve clearances.

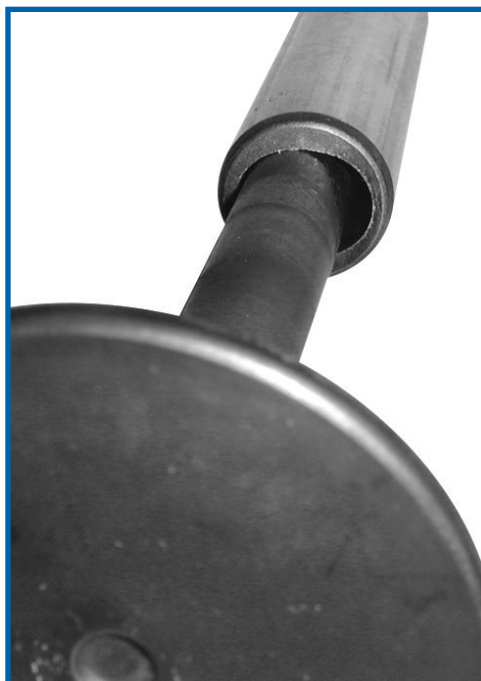
## Excessive valve stem and guide wear

**Symptom:** Valve gear noise, high oil consumption, exhaust smoke on initial start up.  
**Cause:** Too great or too small valve stem to guide clearance. Poor valve stem lubrication or ingress of dirt through the air intake system. It should be noted that the cause of this problem is not always obvious. Unless the cause is readily apparent, additional advice should be sought.  
**Remedy:** Ensure correct valve and guides are fitted. Check alignment, valve stem to guide clearances, valve stem seals and lubrication system.

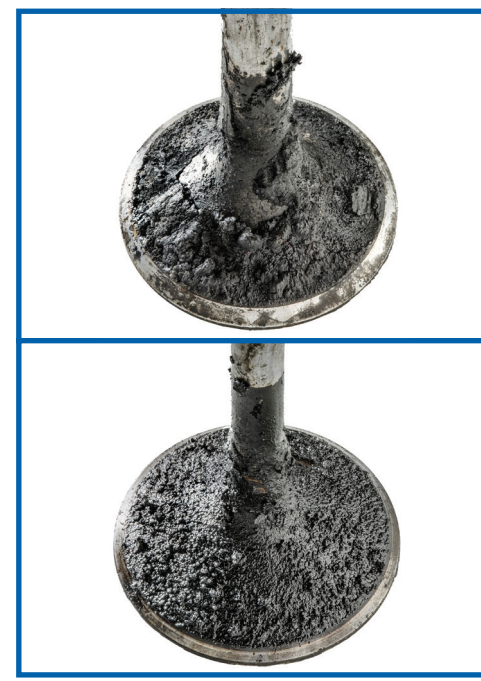
## Inlet valve overhead carbon build-up

**Symptom:** Poor starting. Loss of power. Blue smoke from exhaust (when throttle closed).  
**Cause:** Excessive clearance between valve stem and guide. Valve stem seal failure or wear. Excessive oil supply due to blocked drainage paths. Incorrect grade of lubricating oil used.  
**Remedy:** Check valve stems, guides and stem seals for wear and replace where necessary. Ensure there is no blockage in the engine drainage or breathing systems.

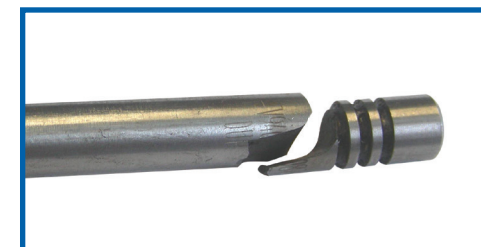
## Valve breakages -fracture at lower cotter groove

**Symptom:** Valve breakage shortly after cylinder head rebuild, during initial start-up or during test run.  
**Cause:** Over extension / "pump-up" of hydraulic lifters (photo 1). Incorrect seating of the valve spring to the head (photo 2). Engine over-speed or weak springs.  
**Remedy:** Where possible fit new hydraulic lifters with new valves. Ensure the engine block is thoroughly cleaned to remove all traces of debris. Take extreme care to seat all valve springs correctly in the recess of the cylinder head. Renew engine oil and replace oil and air filters.

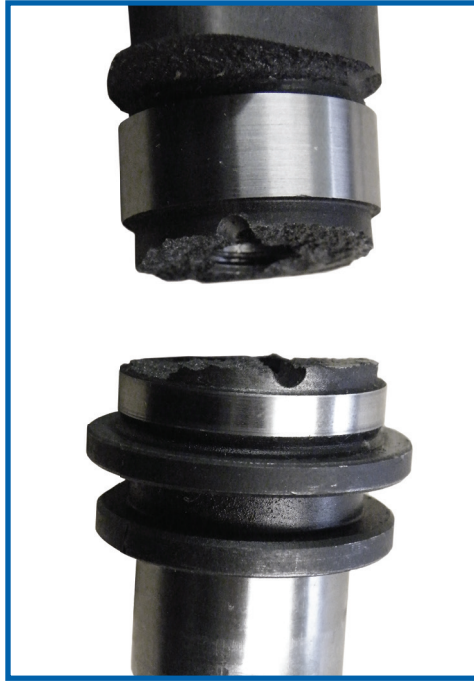
## Broken camshaft

**Appearance:** Camshaft breakage between or through cam-lobes.

**Causes:** Distorted camshaft housing or cylinder head. Incorrect torque sequence and mishandling can also cause similar breakage.

**Remedy:** Straighten or replace camshaft carrier/cylinder head, use correct bolt torque sequence and handle with care. Thoroughly flush the lubricating system, replace cam and followers, prime with extreme pressure lubricant and replace oil and oil filter.

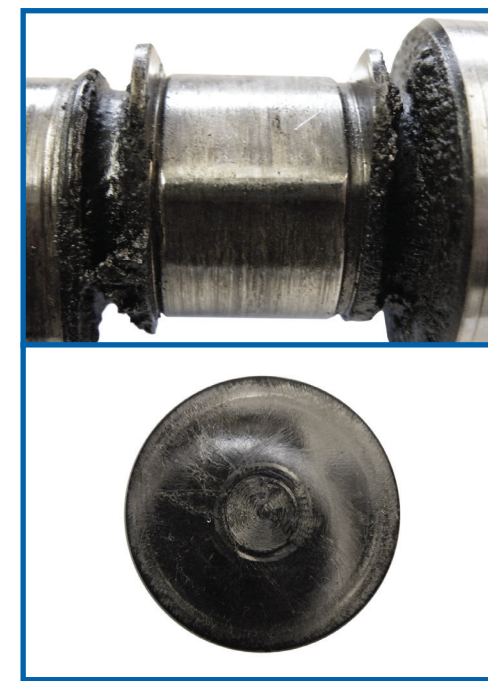
## Cam-lobe and follower wear

**Appearance:** Premature wear of one or more cam-lobes & followers. Follower contact surface will be concaved with chipped edges.

**Causes:** Incompatible cam-lobe & follower contact surface geometry. Often caused by fitting new camshaft with old followers or vice versa. Can also result from lubricant starvation from blocked or restriction in oil supply.

**Remedy:** Thoroughly flush the lubricating system, replace cam and followers, prime with extreme pressure lubricant and replace oil and oil filter. Do not mix old and new components.

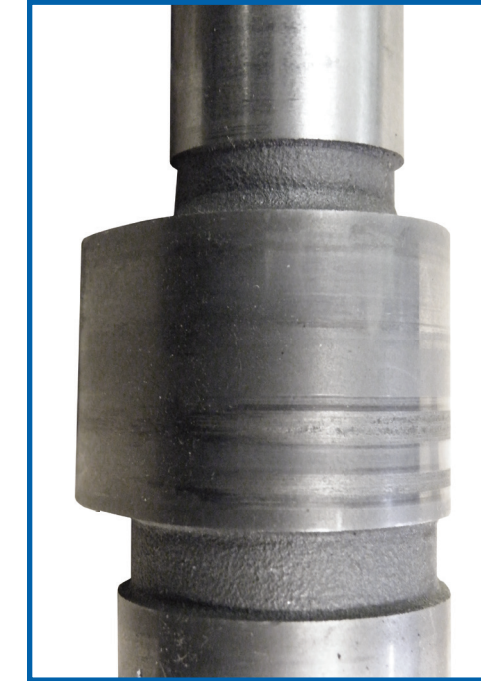
## Base circle contact marking

**Appearance:** Witness marking on base circle of cam-lobes, biased to one side.

**Causes:** Worn hydraulic lifter and/or retainer springs.  
**Remedy:** Replace cam and followers if marks are deep, otherwise set tappets to correct clearance. Thoroughly flush the lubricating system and replace oil and filter.

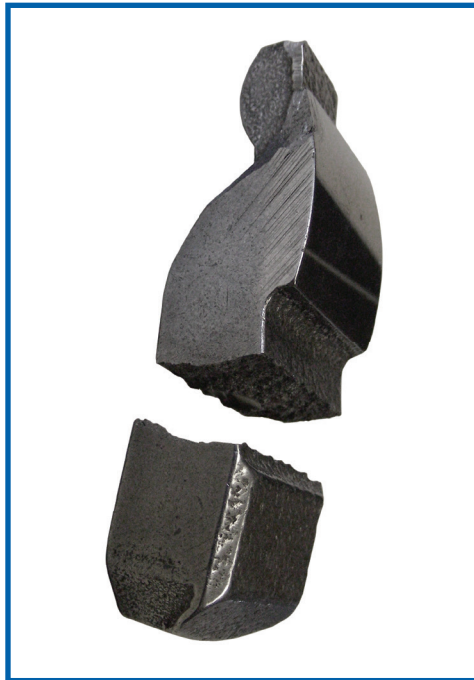
## Follower breakage

**Causes:** Mechanical overload resulting from:

- 1 Sticking or seized valve, resulting in the follower to break due to cam-lobe pressure.
- 2 Piston contact with the valve due to:
  - a Weak valve spring
  - b Over extended hydraulic lifter
  - c Incorrect assembly of valve tip-cap
  - d Timing belt breakage
  - e Or through over high revving of engine.
- 3 Incorrect valve timing.

**Remedy:** Investigate & rectify the mechanical overload cause. Thoroughly flush the lubricating system, replace all damage components, prime cam and followers, with extreme pressure lubricant and replace oil and oil filter.

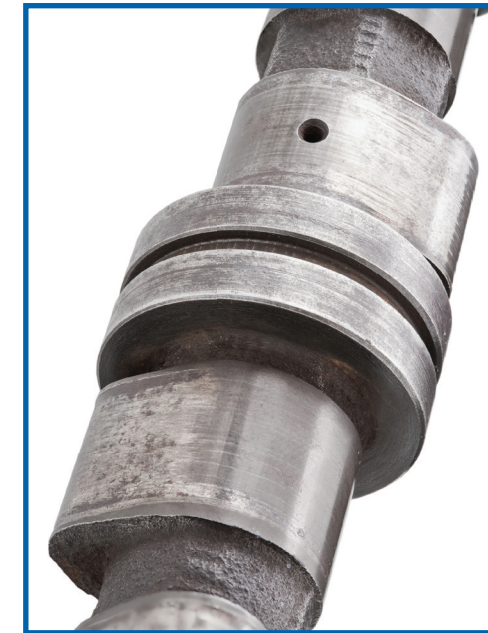
## 'Scored' bearings

**Appearance:** Severe scoring of the camshaft bearings.

**Causes:** Starvation or contamination of oil, i.e. foreign particles circulating in oil.

**Remedy:** Thoroughly flush the lubricating system, replace cam and followers, prime with extreme pressure lubricant and replace oil and oil filter.

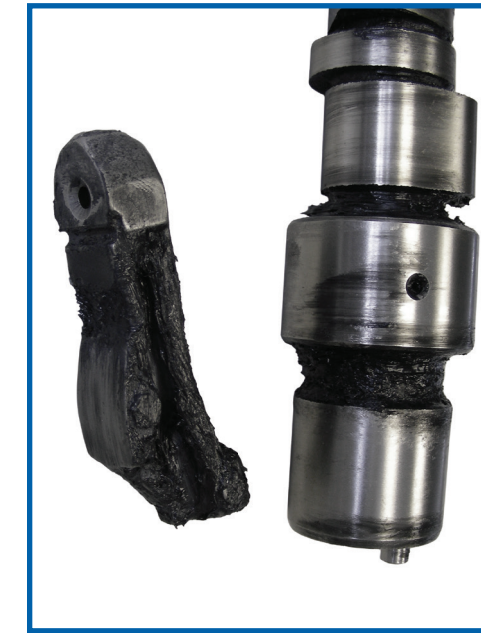
## Carbonised oil deposits

**Appearance:** Carbonised oil build-up on cam and followers.

**Causes:** Excessive operating temperatures resulting from marginal lubrication conditions due to contaminated lubricating oil or blockages/restrictions in oil feed galleries.

**Remedy:** Thoroughly flush the lubrication system, ensuring that all galleries and hydraulic lifters (where fitted) are free from blockages & debris. Install new camshaft and followers, prime with extreme pressure lubricant and replace oil and oil filter.

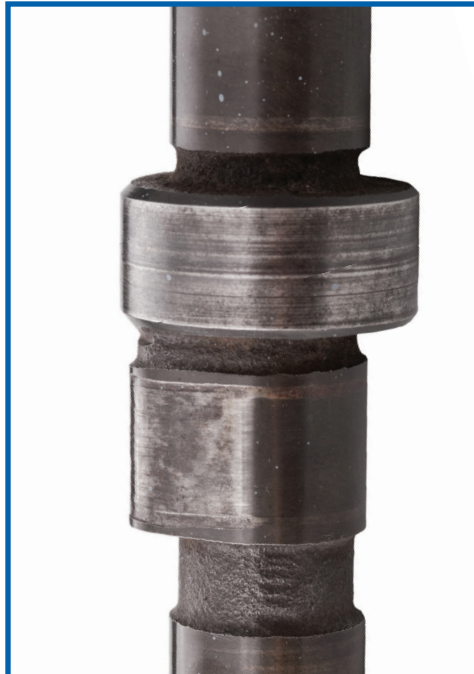
## Excessive cam-lobe wear

**Appearance:** Severe cam-lobe wear.

**Causes:** Starvation or contamination of oil, tappet clearance too tight, excessive valve spring pressure.

**Remedy:** Thoroughly flush the lubrication system, install new camshaft and followers. Adjust tappets to the correct clearances, prime with extreme pressure lubricant and replace oil and oil filter.

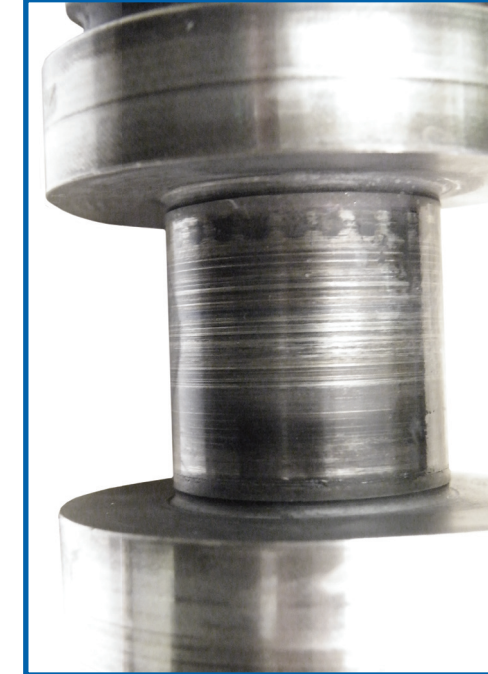
## Overheated camshaft

**Appearance:** Cam-lobes, bearings & followers have a 'blue' discoloration.

**Causes:** Overheated engine possibly due to cooling failure.

**Remedy:** Investigate and rectify the cause of the overheating. Thoroughly flush the lubricating system, replace cam and followers, prime with extreme pressure lubricant and replace oil and oil filter.

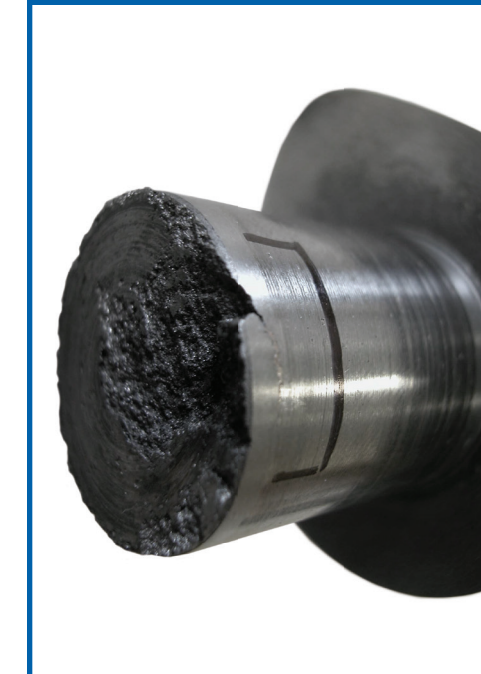
## Physical damage to camshaft & followers

**Appearance:** Cam-lobes, bearings & followers "chipped".

**Causes:** Excessive end-float due to:

- a Worn thrust washer
- b Loose distributor
- c Worn distributor drive gear
- d Or misaligned timing gears

**Remedy:** Investigate and rectify the cause of the damage. Thoroughly flush the lubricating system, replace cam and followers, prime with extreme pressure lubricant and replace oil and oil filter.
