EASY SOLUTIONS BULLETIN

New material technology enhancing the performance of MOOG parts

Metal Sealing Rings on all Link Stabilizers

An increased lifetime due to a more robust design

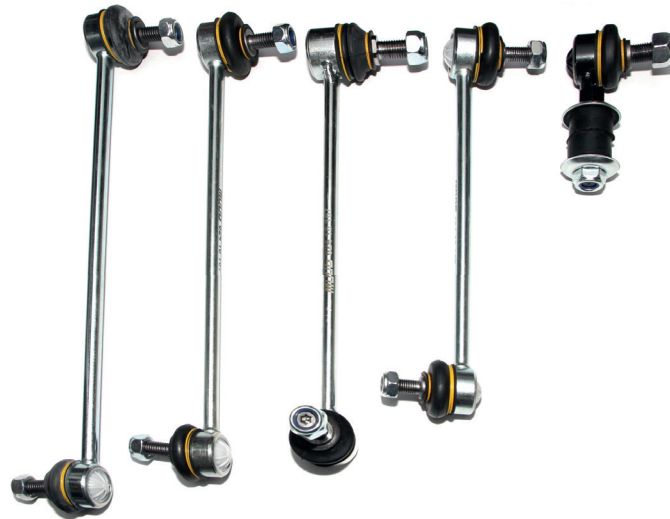
It is standard practice to use plastic sealing rings on stabilizer link bars. However, MOOG found there are some disadvantages as over time they can lose their optimum tightness. As a result dirt and water can penetrate through the seal causing a reduced performance of the ball stud which in turn leads to early wear and subsequent failure.

To overcome this MOOG has changed all the plastic upper sealing rings to metal versions. The premium metal rings ensure an optimum tightness over a longer period of time which guarantees a longer part life by avoiding water and dirt contaminating the ball stud.

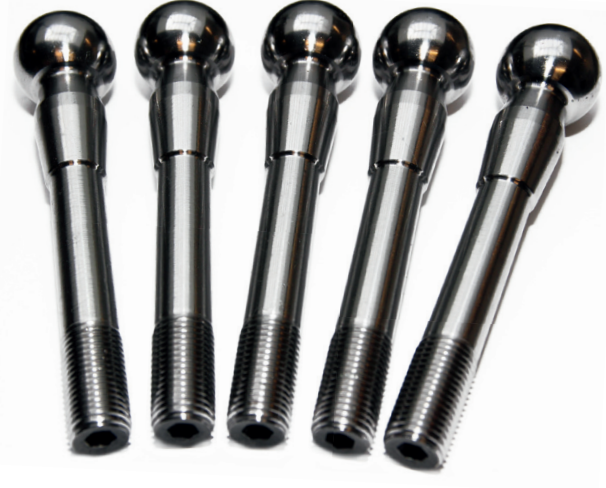
New ball stud material enhancing the performance of MOOG parts

MOOG have upgraded the material used in manufacturing many popular ball studs for their product range. This provides the ultimate tensile strength of up to 30% higher than the old material.

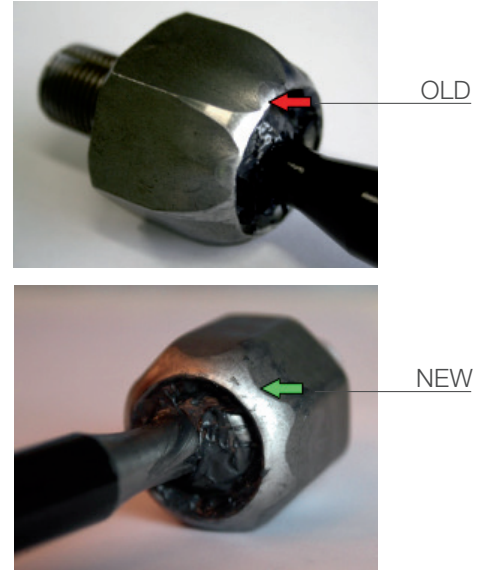
IVECO DAILY
FI-AX-4971

The original hexagonal design of this steering axial rod resulted in uneven segments of the chamfered area (see above picture) and consequently led to the possibility of the ball pin pulling out of its socket under adverse driving conditions, leading to failure of the steering system.

At MOOG our engineers have redesigned the component with an octagonal design and even material thickness around the chamfered area (see picture above). We have also incorporated a larger ball pin with increased diameter in order to prevent pull out even in the most extreme driving conditions.

With this new robust design you can be rest assured that a significantly increased lifetime will be gained by using the MOOG part.

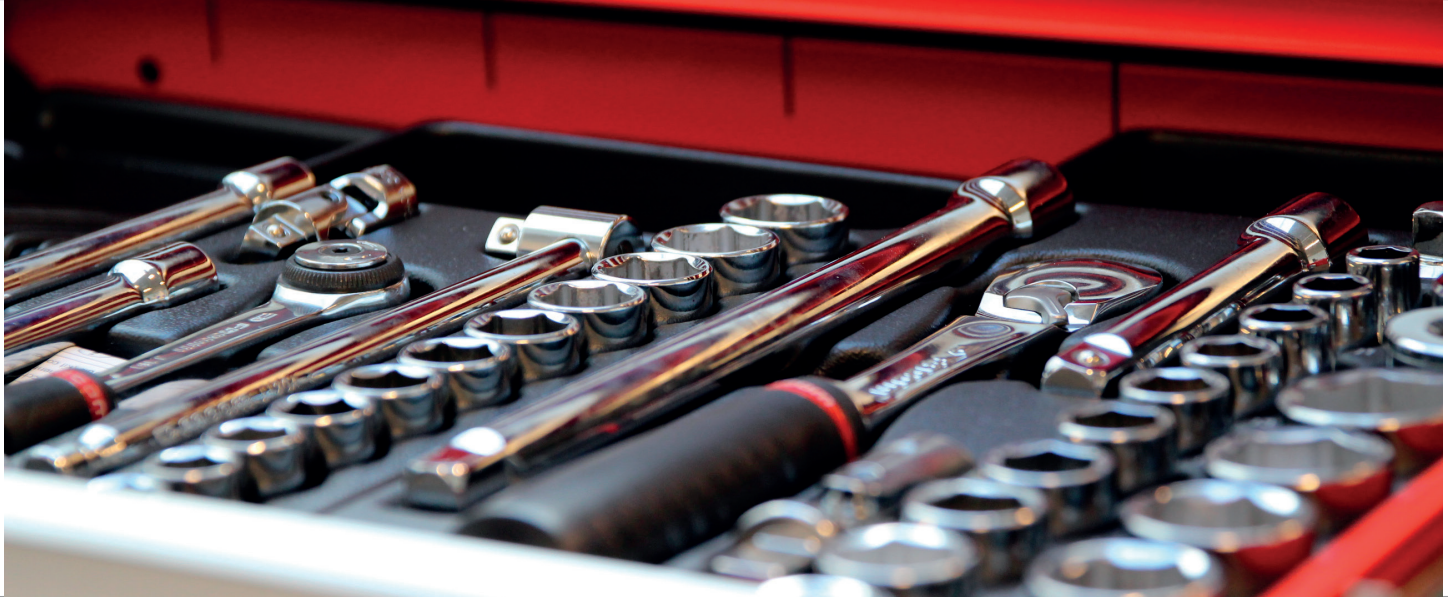
Replacement of rubber to metal components made easy

General or vehicle specific tools to remove and install bushes can be found at your local distributor or on the internet. Such tools **make the replacement of rubber to metal components considerably easier and very often quicker** as there is not a necessity to remove part of the axle where the bush is mounted. In many instances the job can also be completed with the components from your ratchet case, such as, stud threads, nuts and washers, and the sockets.

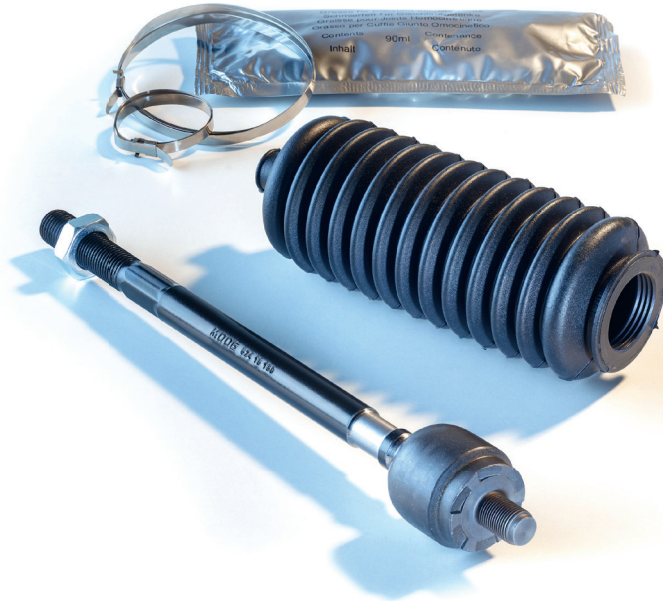
Axial rod & gaiter kits for extra strength and protection

In most cases the axial rod fails due to a split gaiter which allows dirt and water to contaminate the axial rod joint. Therefore each time an axial rod is replaced, it's recommended to replace also the gaiter.

MOOG has introduced a range of axial rod & gaiter kits that provide all the necessary components for the repair. Each kit contains an axial rod, a single gaiter, 2 metal ties to ensure a stronger and durable seal and a sachet of grease.

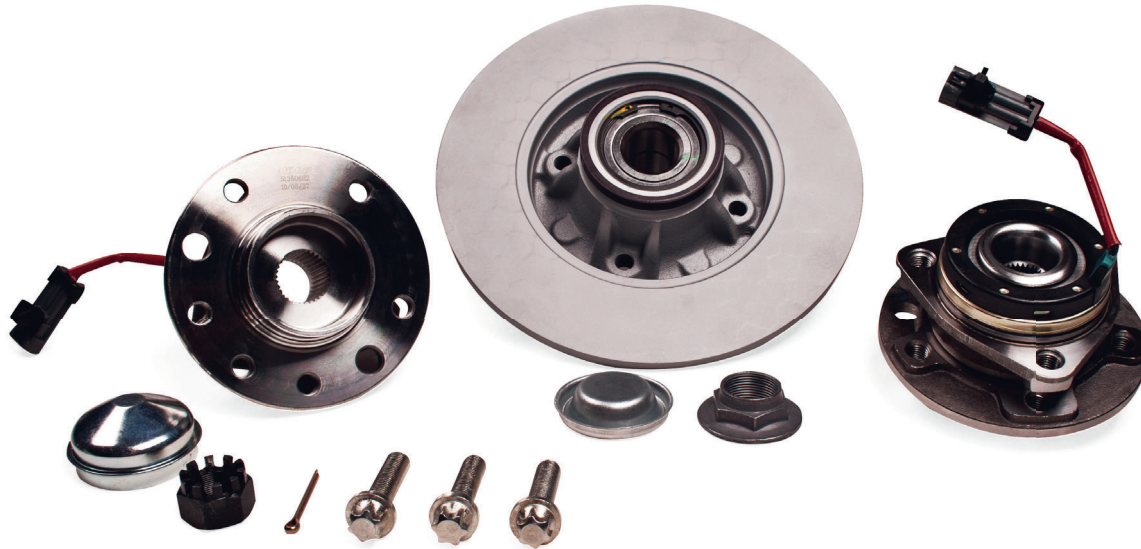
MOOG SIGNIFICANTLY EXTENDS ITS WHEEL END BEARING PROGRAMME

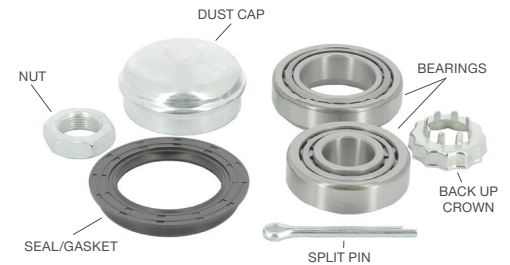
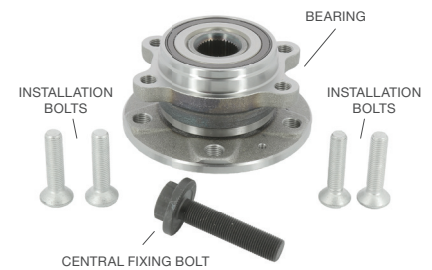
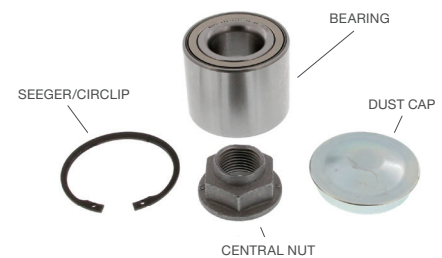
Accessories such as bolts, nuts, seegers/circlips, split pins and back up crowns retain and secure the bearing in the correct position for optimal performance and durability. Loss of bearing retention will result in wheel vibration and/or excessive noise and premature bearing failure.

Moreover, certain accessories such as stretching bolts and nuts (central fixing bolts and nuts) will not hold the torque set at installation when used again. In fact, they will stretch more, loose clamping force and often fracture. Therefore, stretch bolts must ALWAYS be replaced with new ones, and never reused!

Some accessories such as gaskets, seals, dust caps/shields and protection covers, protect the wheel bearing from water or dust intrusion. These accessories often get deformed or damaged when removing the worn wheel bearing. If they get reused, the new wheel bearing will not be fully protected any more. Water and dust or dirt will be able to penetrate into the bearing and will cause premature failure of the bearing.

Every single MOOG wheel end bearing comes with all the necessary accessories inside the box for an easy and perfect installation. The content of each MOOG wheel end bearing kit is listed in the new 2018-2019 MOOG wheel end bearing catalogue (CATMO1802) and can also be found on TecDoc in the tab «Accessory List».

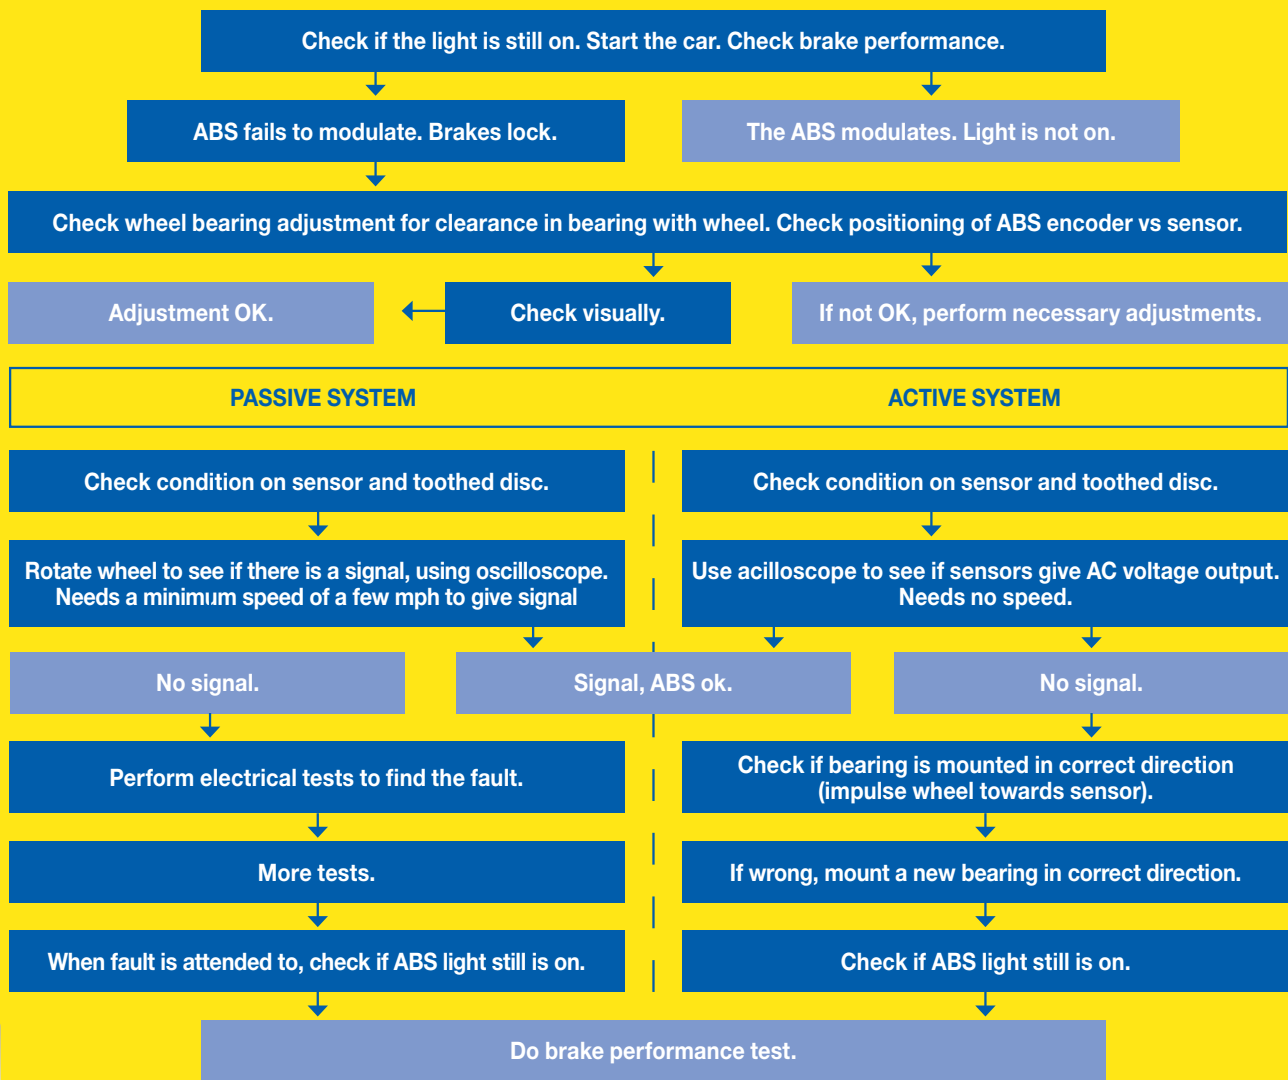
Troubleshooting Wheel End Bearings with ABS functionality

A vehicle's ABS control module is designed to notify the driver with a warning light if there is a malfunction in the system. The malfunction is rarely the modul or ABS itself. It is often one or more sensors, or the wiring to the sensors. The most common ABS problems occur when impulse wheels and / or sensors become contaminated with debris or get damaged.
