# TROUBLE TRACER CHART VALVE TRAIN

# TROUBLE TRACER CHART CAMTRAIN

# VW 1.9 TDi PD – Fitting Instructions

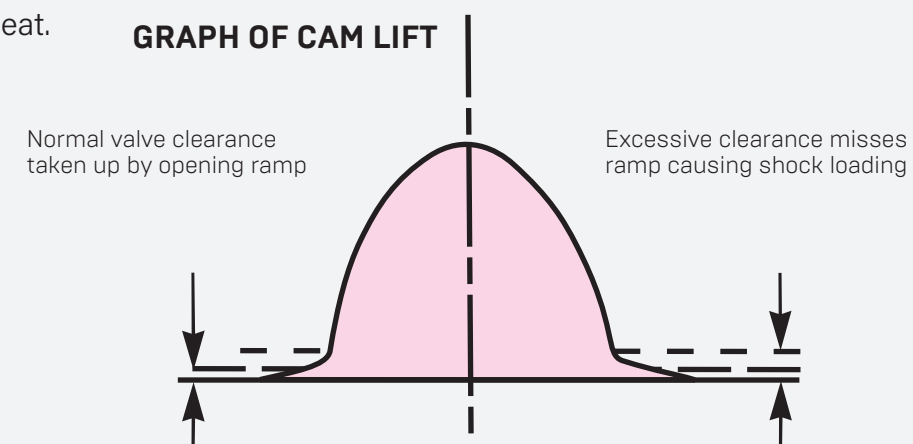
- Initial valve opening and final valve closing occurs very gently. Cam lobe profiles include lifting and lowering ramps to achieve this.
- Ensure the valve clearances are not too great to prevent the valve being hammered open or dropped onto its seat.

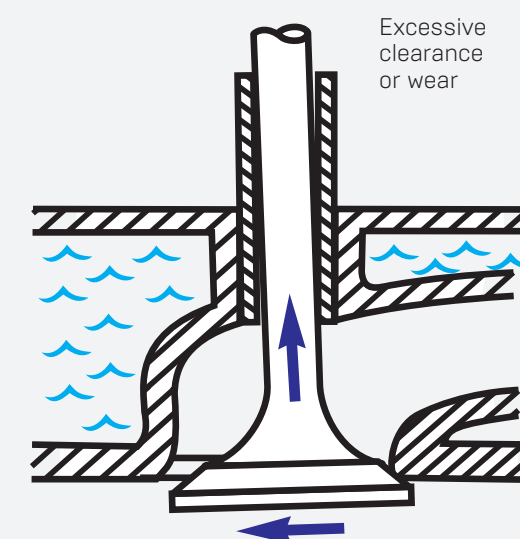
- The valve seat must be concentric with the valve guide. Any eccentricity that exists between the valve seat and guide will force the valve sideways.
- Excessive valve guide wear will occur as a result of this which can lead to a fatigue failure of the valve stem.

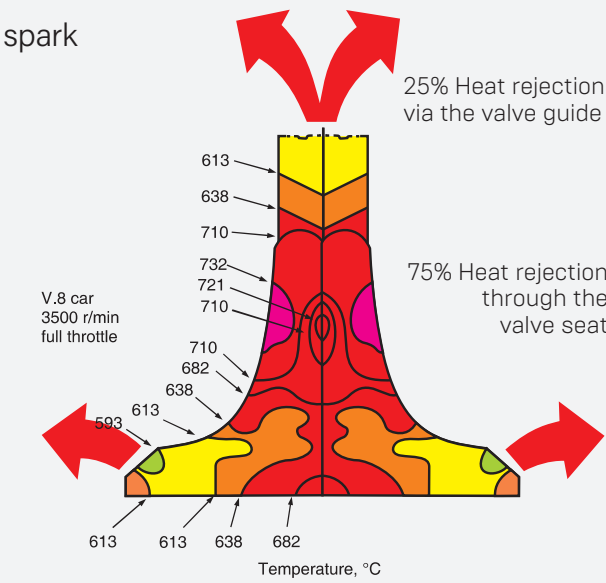
- Typical exhaust valve temperature distribution in a spark ignition engine. Figures are degrees in centigrade.
- An exhaust valve may operate at up to 800 °C, and 75% of its cooling is by transferring heat to the valve seat.
  - Ensure the valve seat contact is correct and as specified by the engine manufacturer.
